NIST NCSTAR 1-5A

**Federal Building and Fire Safety Investigation of
the World Trade Center Disaster**

Visual Evidence, Damage Estimates, And Timeline Analysis

William M. Pitts
Kathryn M. Butler
Valentine Junker

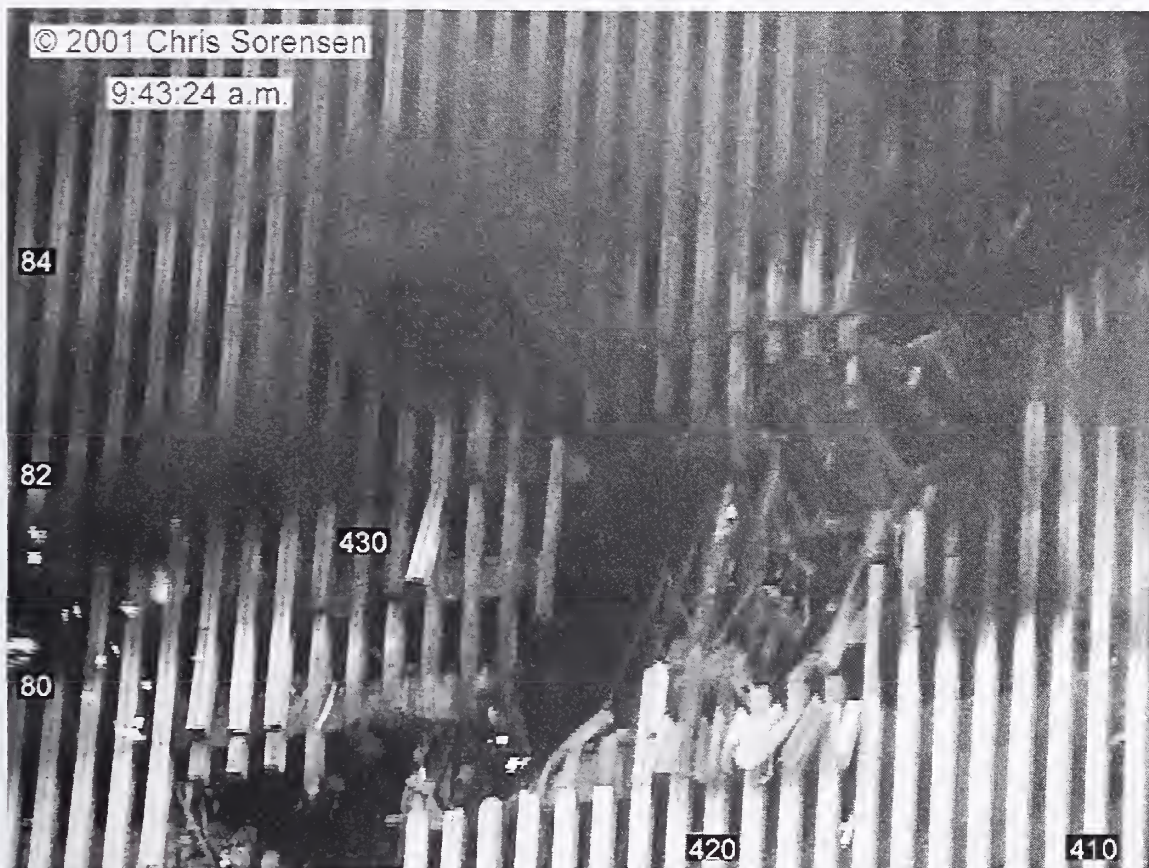
Figure 7-23. A frame captured from a video recording of the aircraft impact location on the south face of WTC 2 is shown. The image has been enhanced by adjusting the intensity levels. Column numbers and floor numbers have been added.

Inspection of Figure 7-22, Figure 7-23, and Figure 7-24 shows that portions of the aluminum cladding that formed the curtain wall for the building were partially or completely removed at locations close to where the aircraft impact occurred. This includes areas on the 80th floor extending from column 80-426 to column 80-431, on the 81st floor extending from column 81-425 to column 81-430, and on the 82nd floor extending from column 82-420 to column 82-426. In Figure 7-24 it can be seen that the aluminum cladding covering the southeast corner on the 82nd floor was pushed outward during the event. It is likely that this occurred as a result of the overpressure within the building generated by burning of aviation fuel released from the tanks of the aircraft. This damage provided a convenient marker for identifying the 82nd floor.

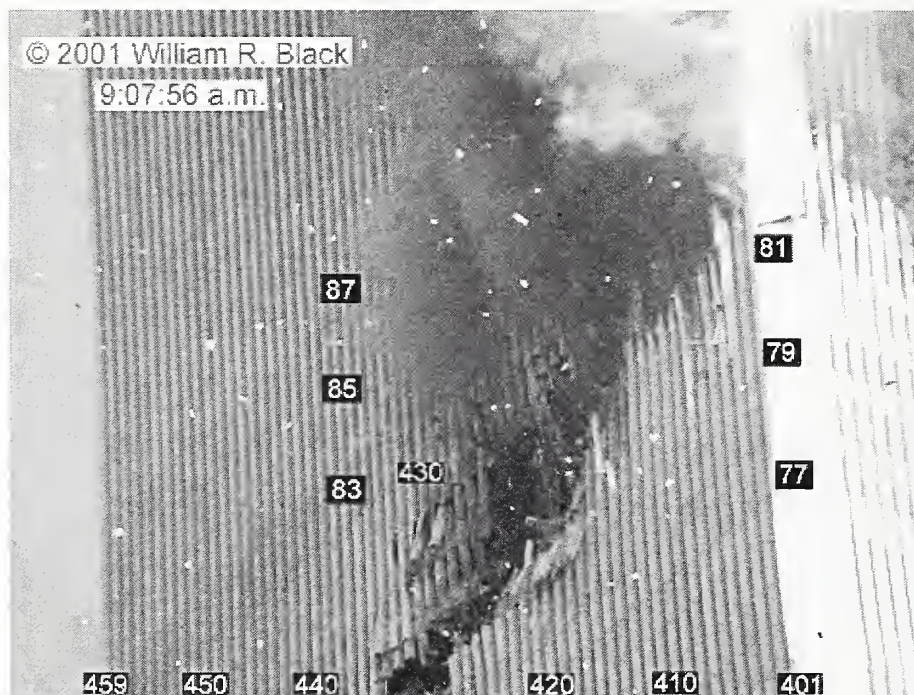
Figure 7-24. This cropped photograph shows the damage to the south face of WTC 2 caused by the aircraft impact. The original image has been enhanced by adjusting the intensity levels. Column and floor numbers have been added.

Close inspection of the photographs and videos reveals a great deal of debris piled on the right-hand side of the opening created by the aircraft impact. This debris, along with the depth of the opening, indicates that floor slabs in this area were partially collapsed by the collision. There is insufficient information to determine the exact areas over which the floor slab collapses occurred or the depth of the collapses inside the building. Visual evidence to be discussed in Section 7.4.3 suggests that at least some of the concrete in the floor slabs was pulverized during the collision.

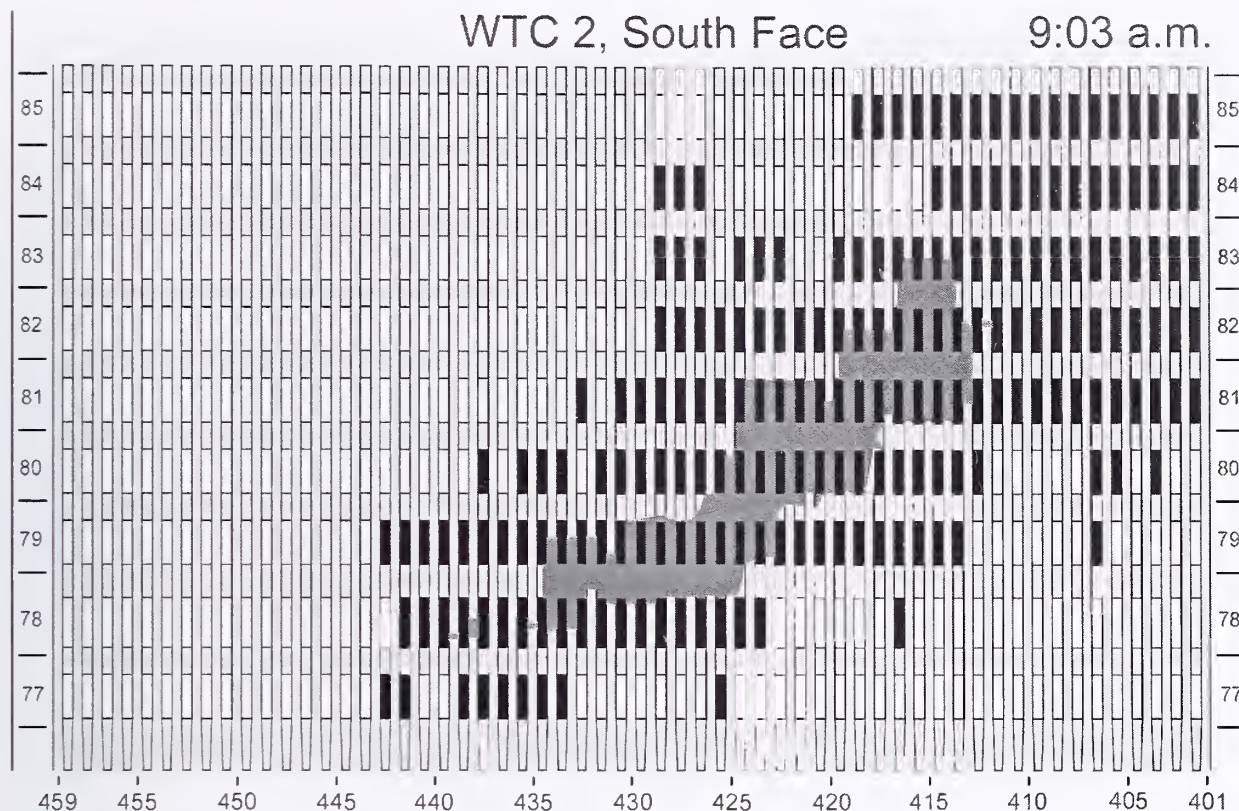
In general, the glass in windows near the aircraft impact location was broken out, while those windows further away tended to remain intact, although some windows were blown open by the overpressure generated by the initial fireball formation within the building. Figure 7-27 is a color-coded representation showing the condition of the windows on the south face in the area immediately following the aircraft impact. Note that a portion of the face was hidden by smoke at this time.

Figure 7-27. A schematic of observed window conditions on the south face of WTC 2 immediately following the aircraft impact is shown. Window and floor numbers are indicated. The colors represent ■ - window broken open, □ - glass in place, and ▒ - not visible.

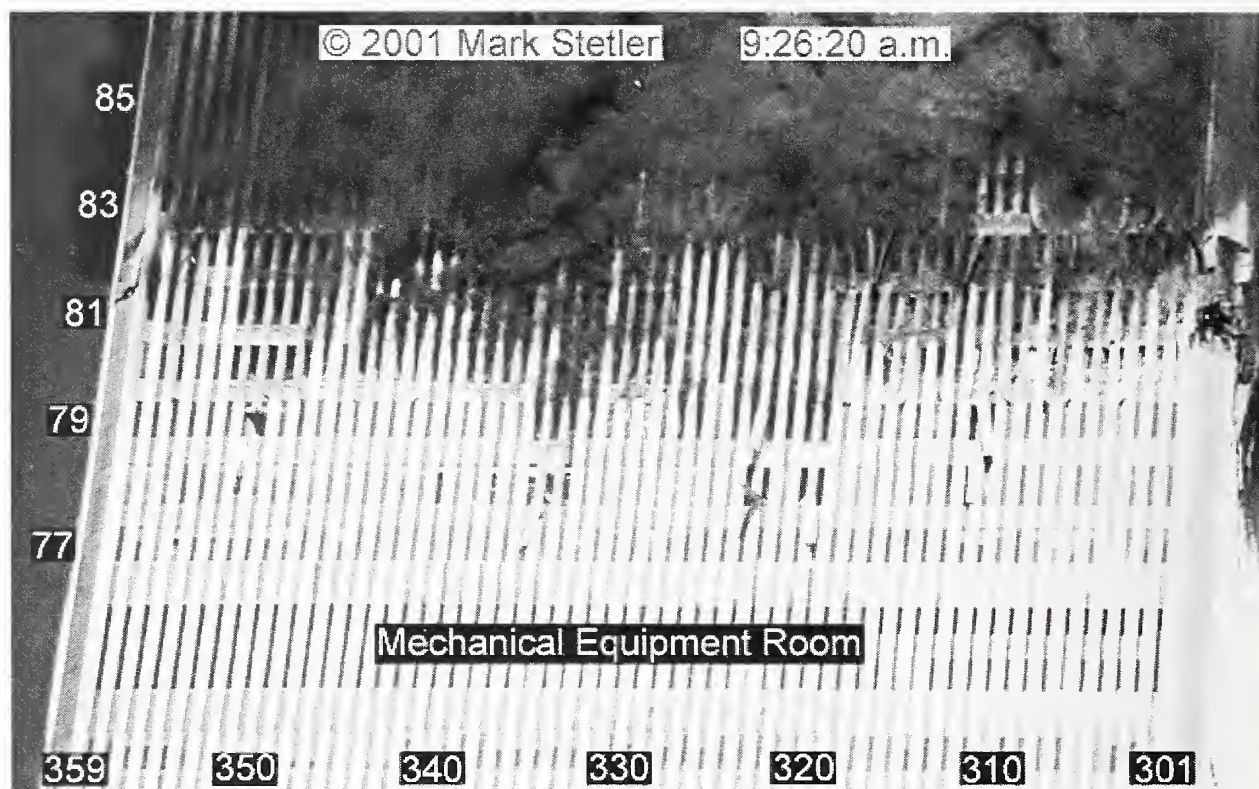
Substantial areas of the aluminum curtain wall have been removed over multiple floors. These areas appear dark due to the color of the underlying column and spandrel steel and fireproofing. In other areas the aluminum column and spandrel covers were disturbed, but remained in place. Video evidence and the wide extent of the damage indicate that much of this damage was due to the overpressures generated within the building by the sudden ignition of atomized aviation fuel and that these overpressures were sufficient to “blow off” numerous sections of the curtain wall. The potential magnitude of the overpressure generated within the tower was discussed in Section 6.5.

Figure 7-28. A cropped photograph shows the east face of WTC 2 at 9:26:20 a.m. The image has been rotated, and column and floor numbers have been added.

Figure 7-28, along with numerous other photographs and videos, was used as the basis for a detailed assessment of the initial damage to the curtain wall on the east face. Figure 7-29 shows the results. The information displayed includes details about the condition of the aluminum facing and whether or not window glass is missing or is still in place. It is apparent that the largest areas of damage were concentrated on the 80th, 81st, and 82nd floors. Based on Figure 7-26, these correspond to the two floors struck by the body of the aircraft (80th and 81st floors) and the floor where the majority of fuel from the starboard fuel tank was dumped (82nd floor). Interestingly, much less damage is apparent on the 79th floor, which is the floor where most of the fuel from the aircraft's port tank should have been released.

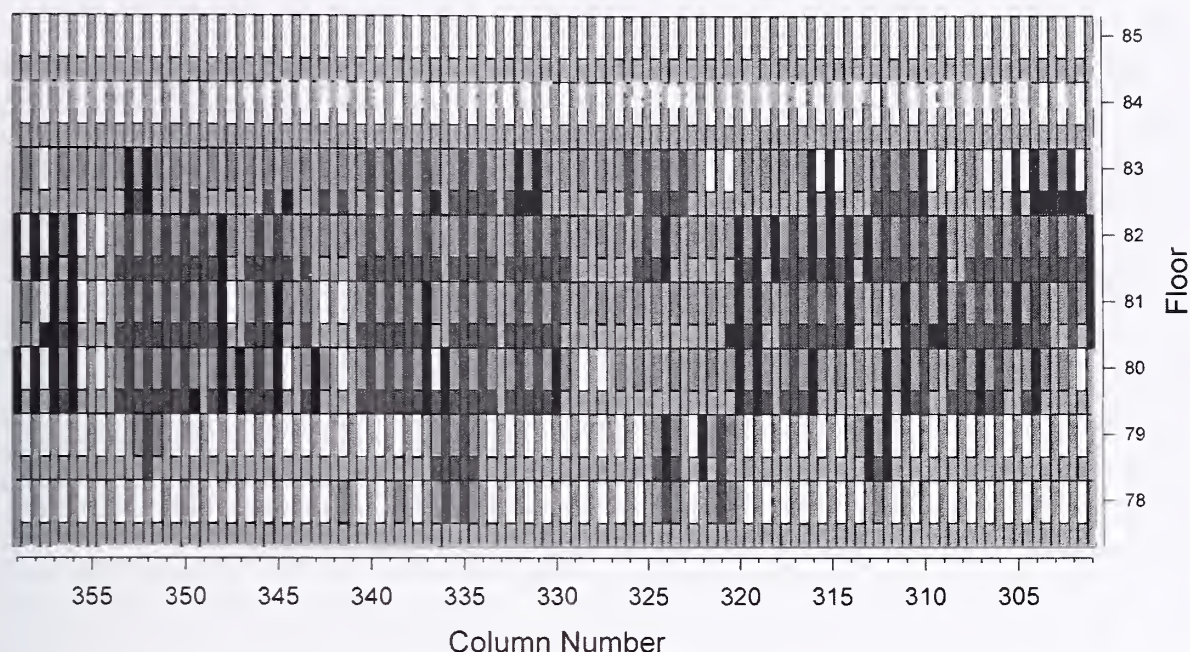
Figure 7-29. A color-coded map of the damage to the east face of WTC 2 as a result of the aircraft impact and fireball is shown. Details concerning damage to the aluminum curtain wall (■ - undisturbed, ■ - disturbed but still in place, and ■ - aluminum facing missing) and windows (■ - glass missing and ■ - glass in place) are combined.

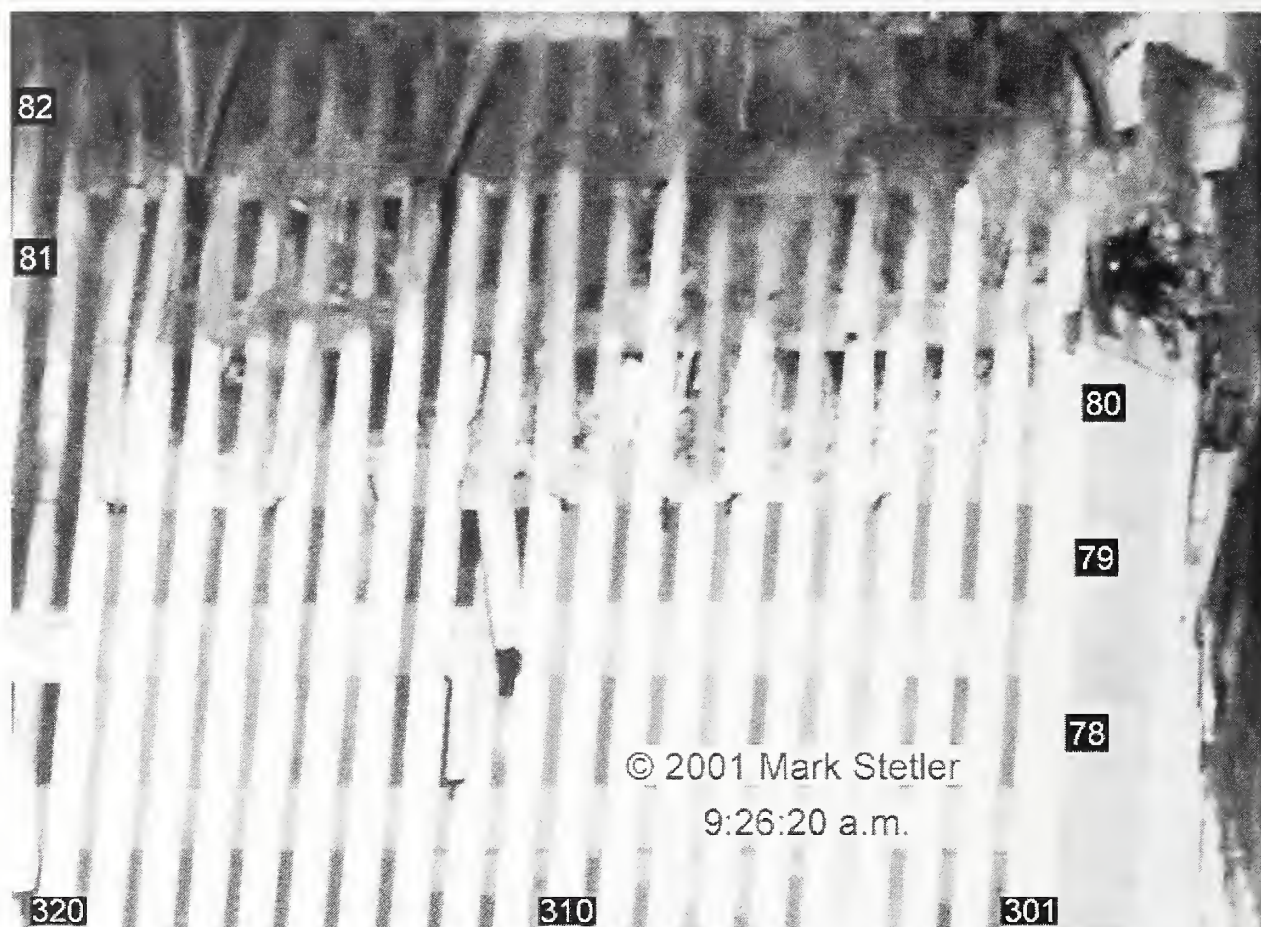
Figure 7-30 shows an enlarged region of the northeast corner of the tower taken from Figure 7-28. Large piles of debris can be seen through the windows near the corner on the 80th and 81st floors. It is likely that a large fraction of this debris was derived from the aircraft, since its body impacted on these two floors (see Figure 7-26). This suggests that either the debris was deflected from the core or that the aircraft was moving toward the east when it struck the tower, since the nose struck near column 422 on the south face.

Figure 7-30 also shows that the aluminum panels on the 80th and 81st floors of the northeast corner have been pushed out and partially removed. This damage was present immediately following the aircraft impact. Observations included in Table 7-1 indicate that the initial damage in this area appeared 0.4 s after the aircraft impact. As discussed below, it is likely that one of the engines of the aircraft passed through this corner. A pile of debris can also be seen jutting from this corner on the 81st floor. The debris in the corner can be seen more clearly in Figure 7-31, which was shot from the northeast. Additional debris extends from windows on either side of the corner.

Figure 7-30. This photograph showing a portion of the east face of WTC 2 was cropped from the image shown in Figure 7-28. The image has been rotated, and column and floor numbers have been added. Note the large piles of debris on the 80th and 81st floors.

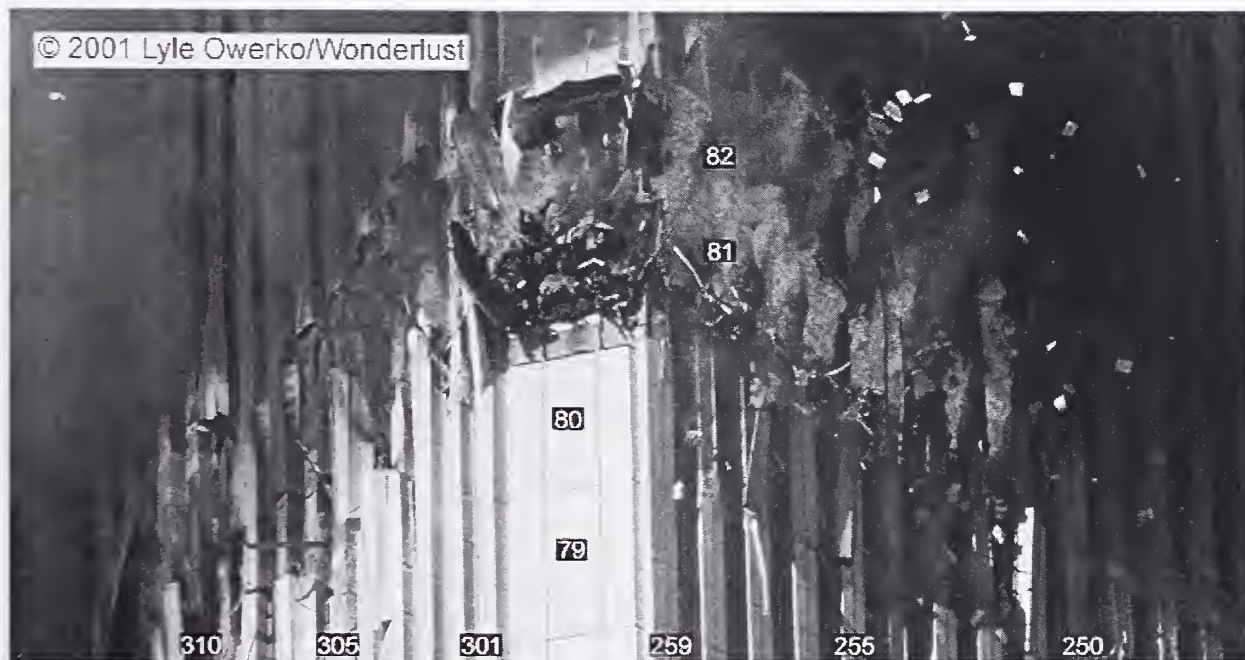
Figure 7-31. This cropped photograph shows the northeast corner of WTC 2. This image was recorded between 9:05 a.m. and 9:19 a.m. Column and floor numbers have been added. The corner aluminum panels on the 81st and 82nd floors have been pushed outward. A large pile of debris is evident in the opening on the 81st floor, and a vertical steel column, numbered 82-300, can be seen on the 82nd floor.

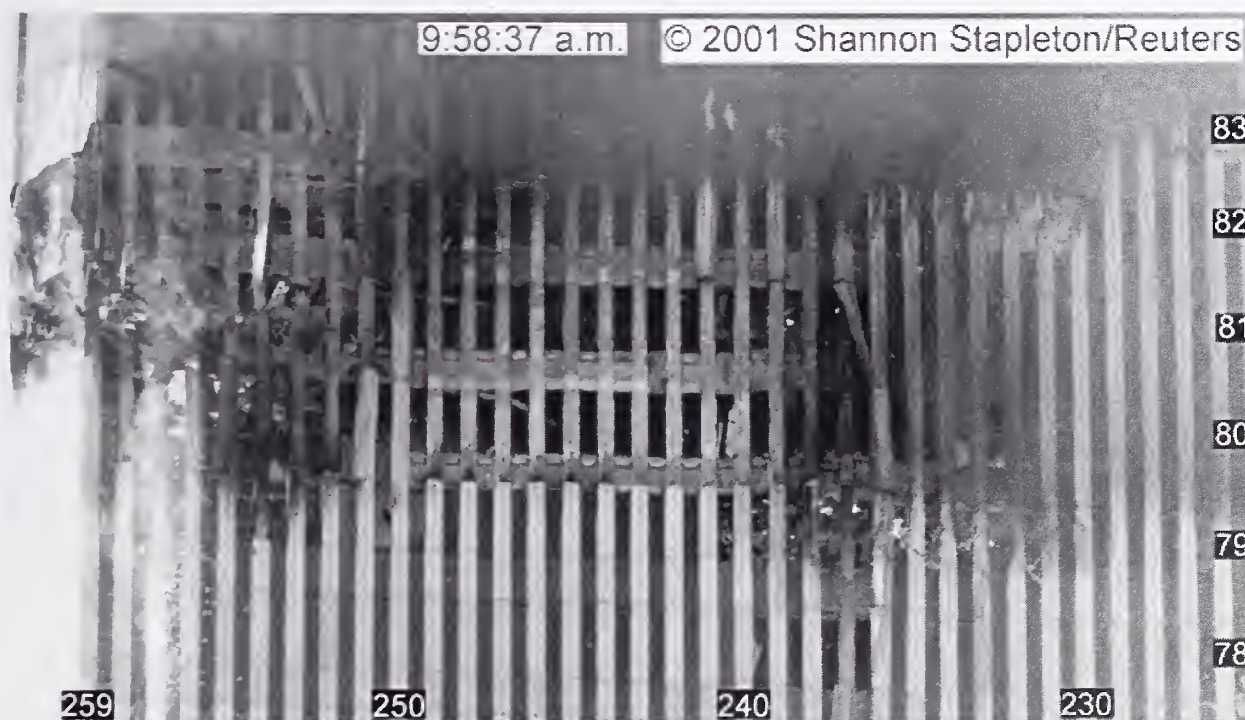
A casual inspection of Figure 7-32 reveals that significant areas of the aluminum curtain wall are missing. Reviews of early photographs and videos indicate the vast majority of this damage was present immediately after the fireball created by the aircraft impact dissipated. The most prominent region of missing curtain wall is a roughly rectangular area extending from column 238 to column 249 and covering the 80th, 81st, and 82nd floors. This area coincides with the locations (see Table 7-1) where the nascent fireball was first observed on this face 0.63 s following the aircraft impact. As will be discussed in more detail in Chapter 9, the observed fire behavior in this area following the fireball and before the

Three large piles of debris are evident through the windows on the north face. Two of these piles start at the northeast corner and extend out about eight windows toward the west on the 80th and 81st floors. These are the same floors where similar piles were observed on the east face at the north edge, suggesting that the debris essentially filled up the corners of the tower on these two floors. The third pile of debris can be seen on the 79th floor extending from roughly column 79-231 to column 79-240. As indicated in Table 7-1, these windows overlap an area where a distinct line of fire appeared 0.92 s after the aircraft impact.

Closer inspection of Figure 7-32 shows that column 253 has been severed just below the spandrel between the 81st and 82nd floors. The adjacent column, 81-254, is bent and split. This damage must be the result of a large part of the aircraft passing through the tower. As indicated in Table 7-1, such an object was observed breaking through the north face at this location 0.5 s after the aircraft impact on the tower.

Figure 7-32. A cropped and enhanced photograph of WTC 2 taken at 9:58:37 a.m. shows the east side of the north face. Piles of debris are evident on the 80th and 81st floors at the northeast corner and on the 79th floor to the right of column 241. The “cold” spot extends over the 80th to 82nd floors from column 238 to 249.

In the photograph the glass for four windows, 78-236 to 78-239, is missing. Again, this observation is consistent with the events listed in Table 7-1, which indicates that this damage first appeared on the north face 0.86 s after the aircraft impact. While not shown in Figure 7-32, the uncropped version of this photograph and numerous earlier photographs and videos indicate that the glass in windows 78-224 to 78-226 was broken out during the aircraft impact. The time line in Table 7-1 indicates that façade damage and dust appeared at this location 0.56 s after the aircraft impact. It is interesting that even though aircraft and/or parts of the building exited the north face on the 78th floor at two locations, no fire was observed emanating from windows on this floor.

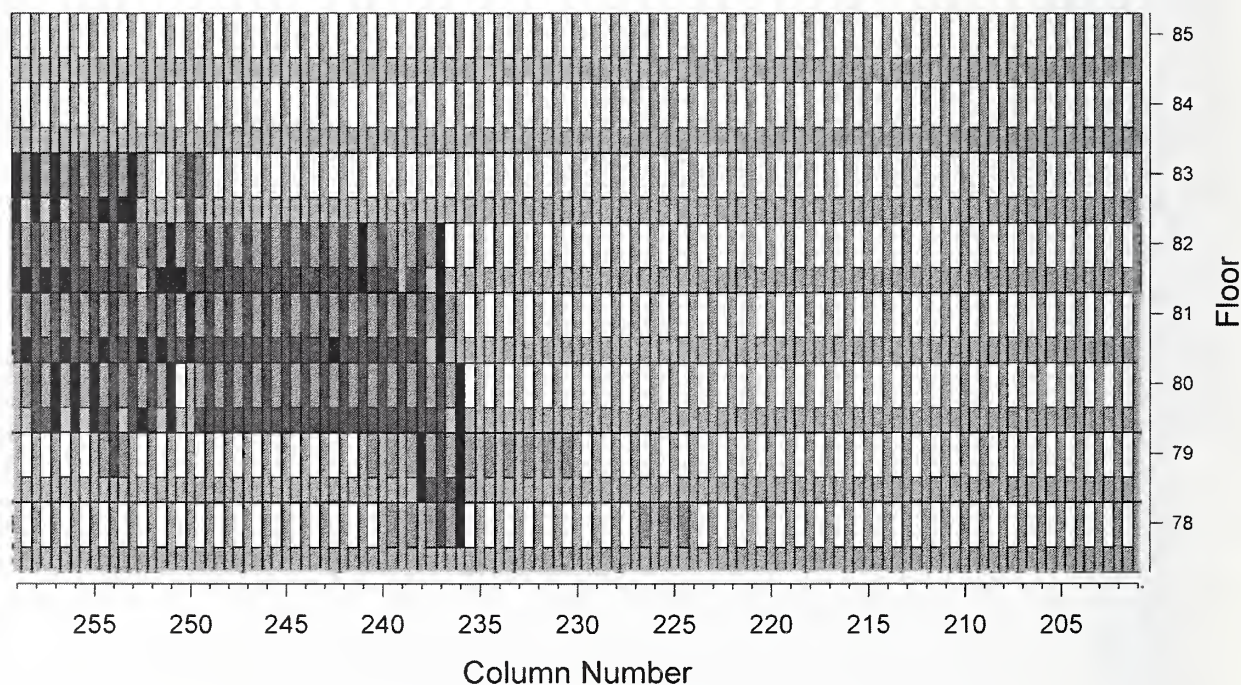
Figure 7-32, along with other photographs and videos, was used to develop the map for exterior damage shown in Figure 7-33 for the north face of WTC 2 that combines damage to the aluminum facing and window glass that make up the curtain wall. Damage on this face is inclined at an angle which roughly matches that at which the aircraft struck the tower on the south face on the opposite side of the tower. This suggests that debris from the aircraft tended to pass straight through the tower, perhaps passing between and being guided by the floor slabs.

Figure 7-33. A color-coded visualization of initial damage to the north face of WTC 2 is shown. Information concerning damage to the aluminum on the curtain wall (■ - undisturbed, ■ - disturbed but still in place, and ■ - aluminum facing missing) and windows (■ - glass missing and ■ - glass in place) are combined.

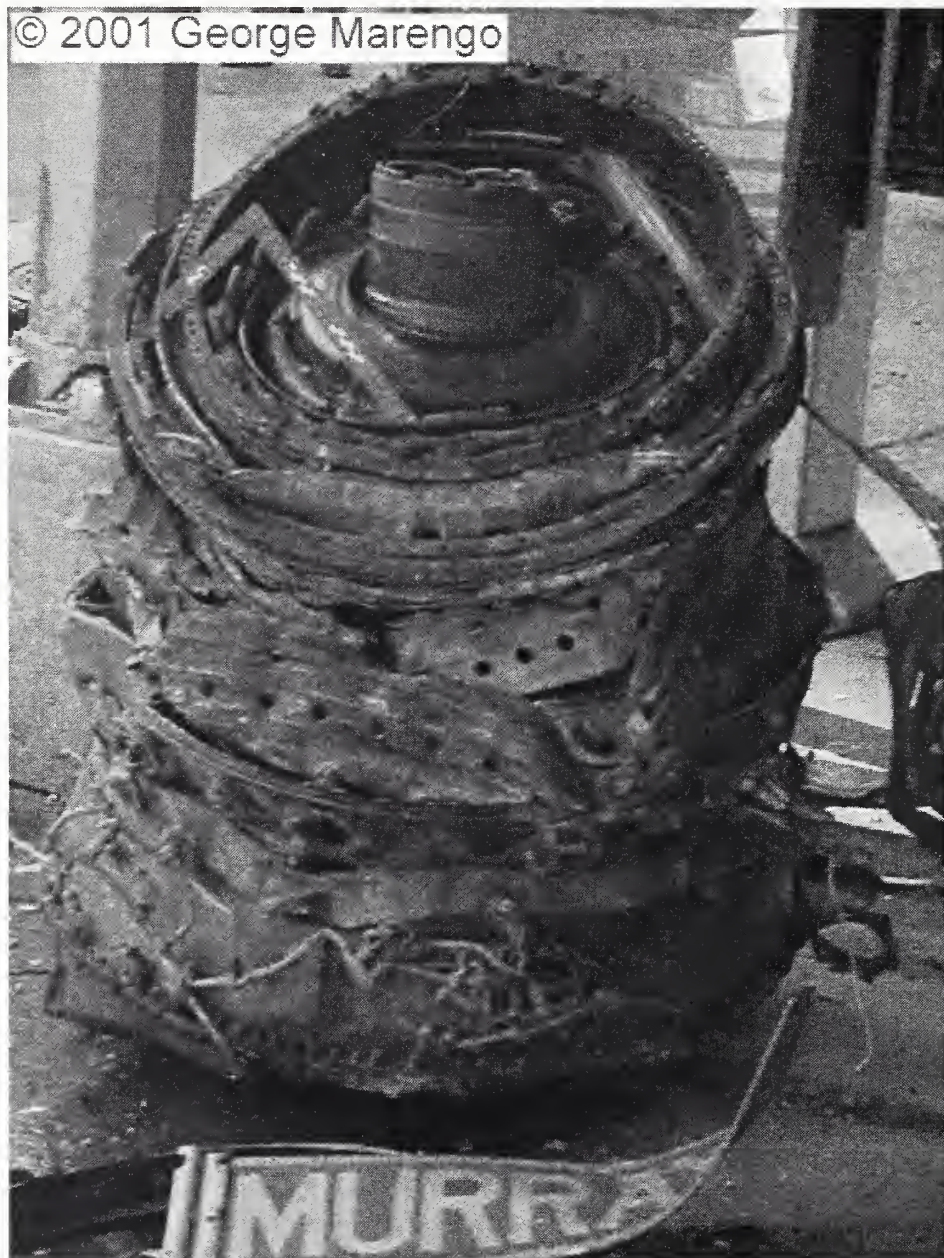
It is likely that the two large aircraft pieces visible in Figure 7-5 are the part of an engine and the landing gear subsequently identified. If correct, this means the two large aircraft pieces highlighted in Figure 7-5 landed at the corner of Church Street and Murray Street and 45 Park Place. The resting locations of the debris indicate the spiraling object was the engine (a plausible conclusion based on the shape of the component in Figure 7-34), and the flaming component was the landing gear.

Figure 7-34. This photograph shows what appears to be part of an aircraft engine lying near the northeast corner of the intersection of Church and Murray Streets. The photograph was taken prior to the collapse of WTC 2.

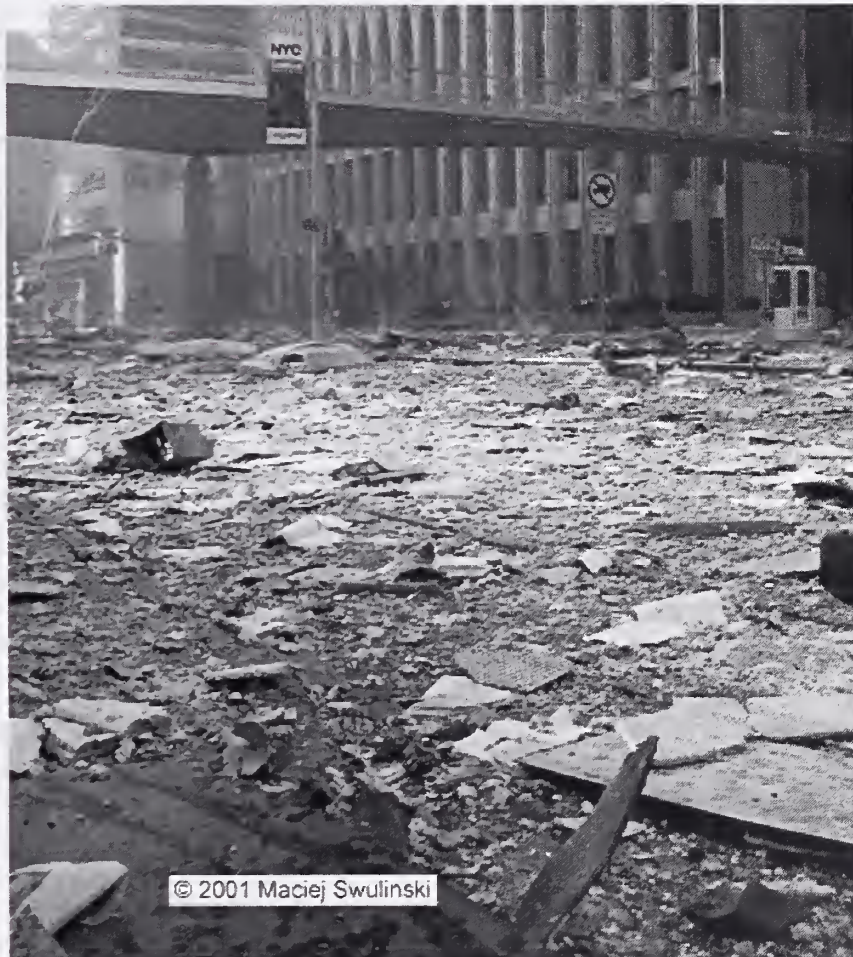
Figure 7-35. This cropped photograph taken from near the corner of Greenwich Street and Liberty Street shows debris on Liberty Street following the second aircraft impact on WTC 2. WTC 2 and WTC 3 are located in the background.

The debris in Figure 7-35 and Figure 7-36 most likely made up a portion of the dust cloud evident on the south face of WTC 2 in Figure 7-3 and Figure 7-9. This material was blown backward out of the tower by the overpressure generated by the initial fire inside the building that appeared shortly after the aircraft impact. The relatively large amount of what appears to be concrete, as well as its small size, suggests that the aircraft impact pulverized a significant amount of concrete floor slabs as it entered the tower. This is consistent with the large scooped-out cavity seen in the aircraft impact location (see Figure 7-22 to Figure 7-24). As noted previously, it has not been possible to visually observe the depth of such damage.

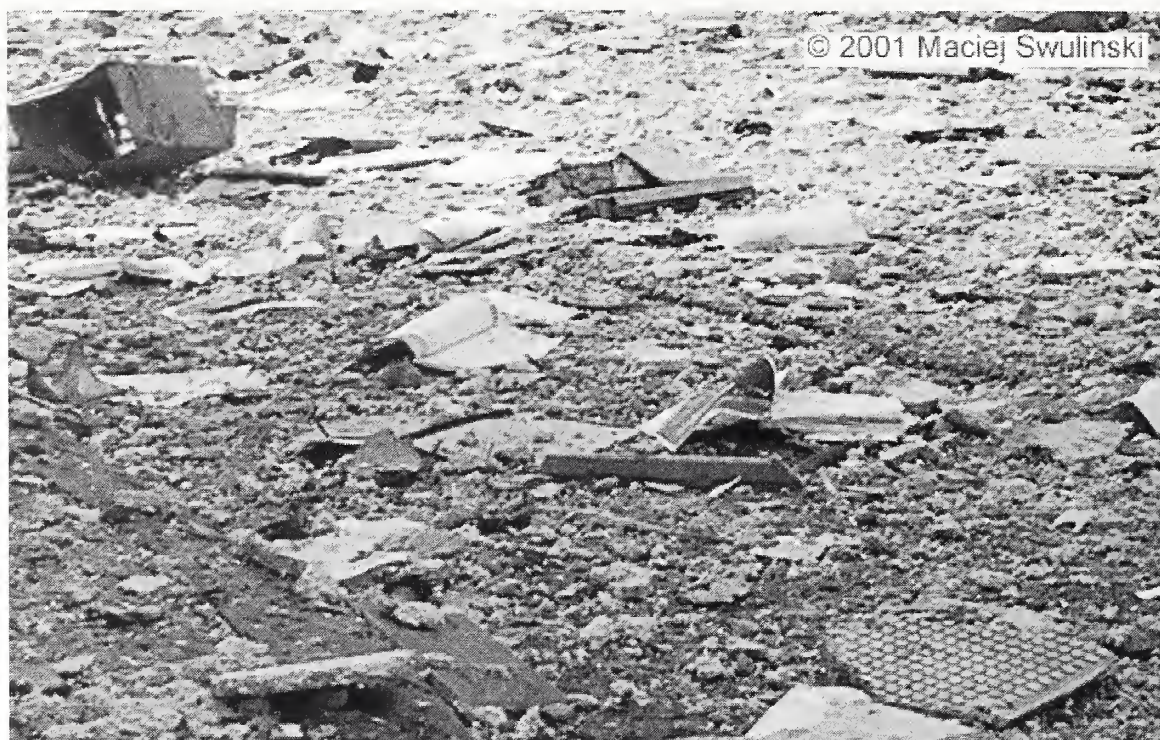
Figure 7-36 shows an enlarged portion of Figure 7-35. This photograph is typical of other photographs of the debris taken in the vicinity. Various types of debris, including papers and cardboard boxes, are identifiable. There is also a great deal of what appears to be crushed concrete. A dimpled material is evident in the foreground. Similar material is seen elsewhere in the street debris. This material is likely a portion of a ceiling tile.

Figure 7-36. A close-up of the debris on Liberty Street created by the second aircraft impact is shown in an enlarged section from Figure 7-35.

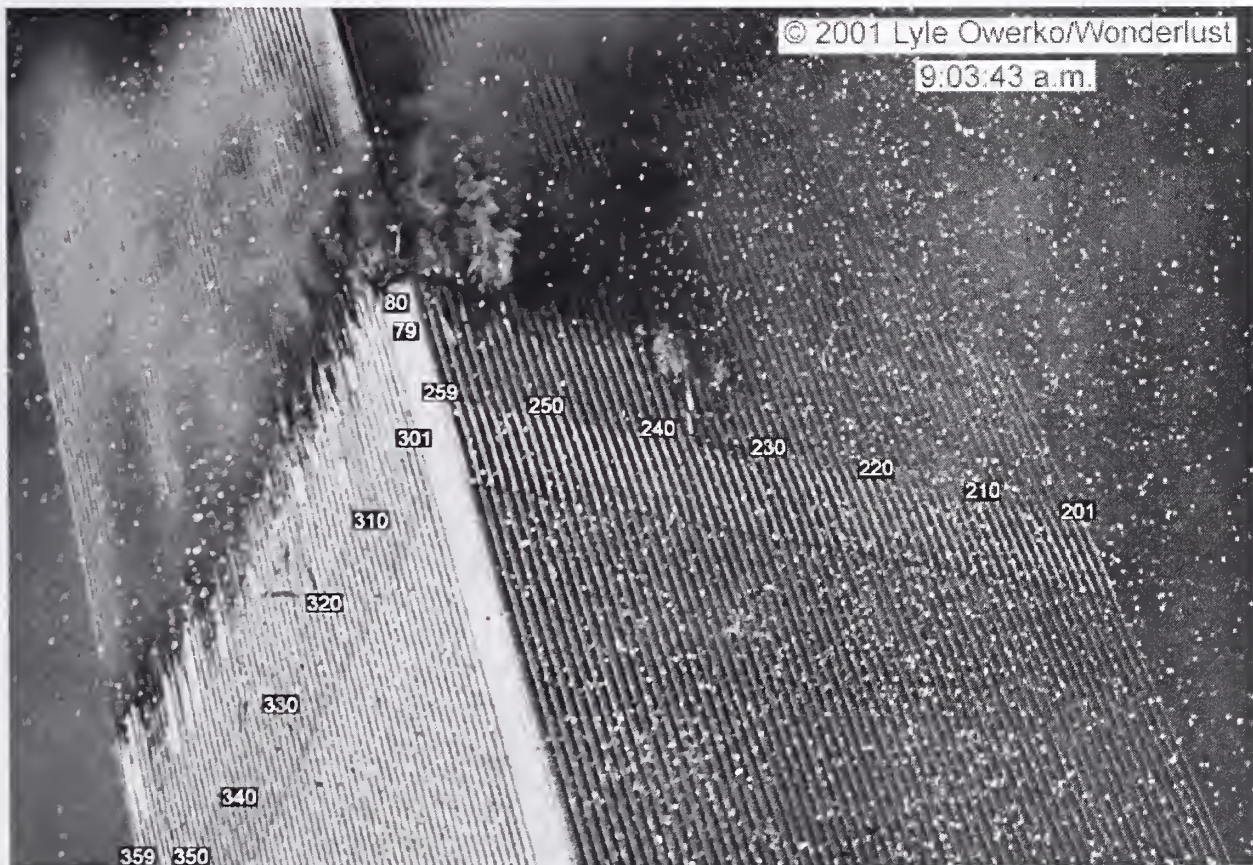
After the initial ten-second period following the aircraft impact, most of the large fires burning around WTC 2 began to decrease in size and to recede back into the building. In many locations fires were no longer visible after about 30 s. Figure 7-37 shows a photograph that was taken 44 s after the aircraft impact. Comparison with Figure 7-6 to Figure 7-8 indicates to what a large extent the flames coming from open windows have died down. Only relatively small fires are now observed on the east face. Substantial flame extension is still present on the north face, with large flames evident on the 81st floor near the northeast corner, and somewhat smaller flames located near the center of the north face on the 79th floor. Both of these flaming regions are in areas where large piles of debris can be seen through the windows. The cold spot discussed earlier stands out between the two fire zones due to the absence of flame. Similar close-up photographs and videos from the south are not available in the database for this early time, but more distant images indicate only a few isolated small fires were present on this face at this time.

Figure 7-37. This cropped photograph showing WTC 2 from the northeast was taken from the corner of Vesey Street and Church Street at 9:03:43 a.m., i.e., 44 s after the aircraft impact. The intensity levels have been adjusted, and column and floor numbers have been added.

The lack of significant burning in interior regions in the immediate aftermath of the fireballs is also reflected in the absence of heavy smoke coming from the tower. Some smoke is evident in Figure 7-37, but it does not obscure the faces of the tower. Most of it seems to be emanating from the flaming areas visible near the outer edge of the tower. Figure 7-38 shows the east side of WTC 2 at roughly the same time. Only very light smoke is present, and most of the façade area above the floors with fires is visible.

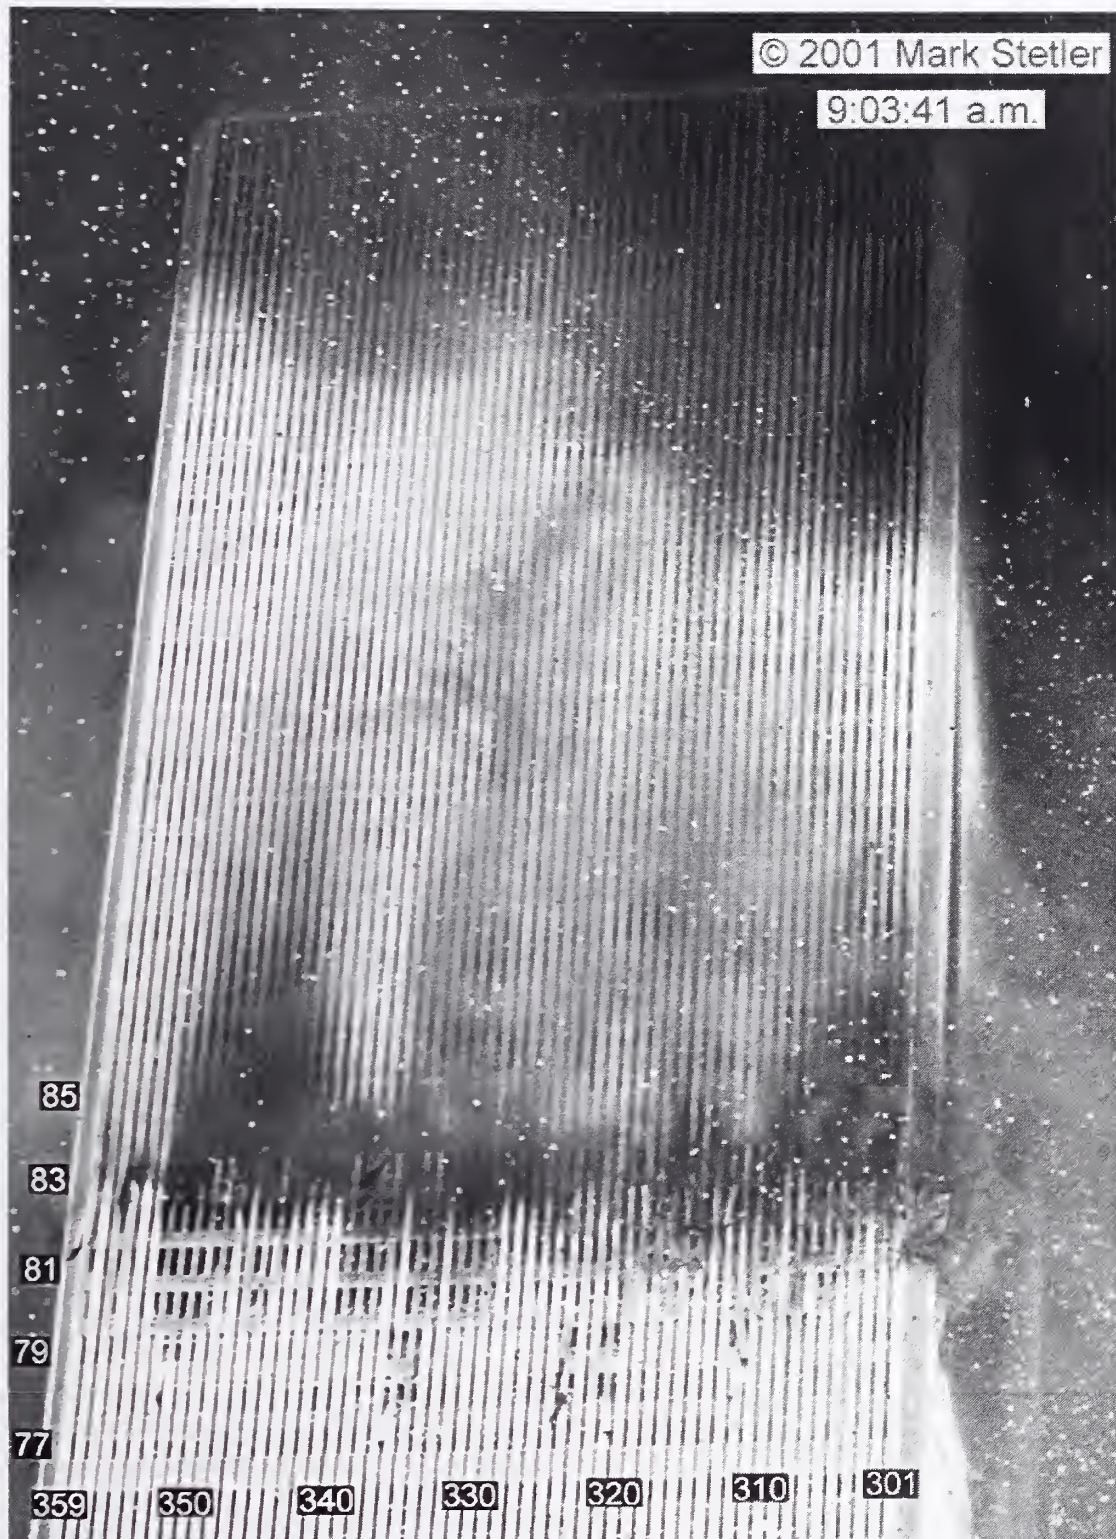
Figure 7-38. This cropped photograph shows the east face of WTC 2 at 9:03:41 a.m. Column and floor numbers have been added.

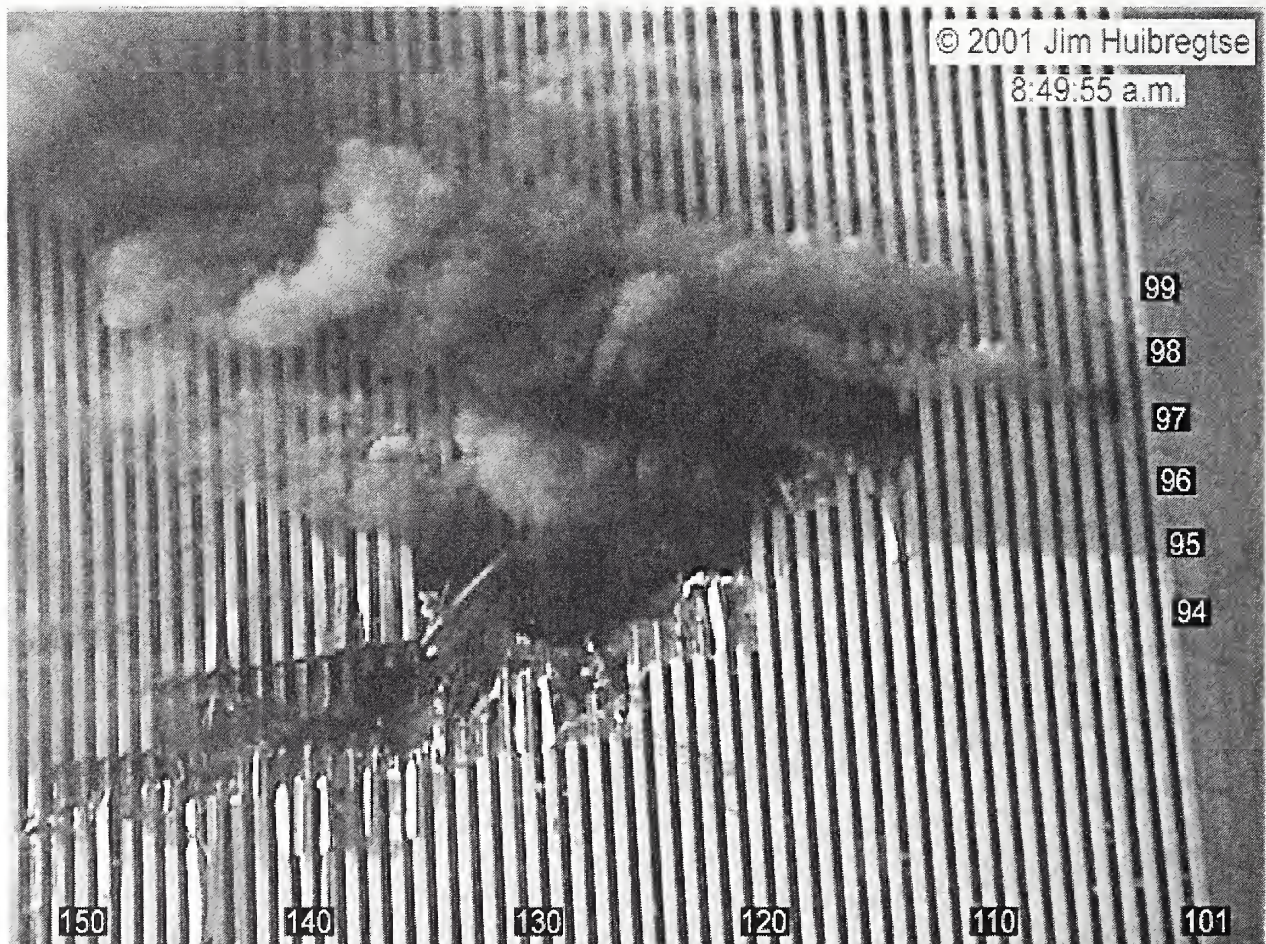
Figure 8-1. This image is extracted from a video recording that shows the north face of WTC 1 at 8:49:55 a.m. Column and floor numbers have been added.

At 8:50:55 a.m., light smoke began to come from window 97-144 on the 97th floor, which is located on the north face to the east of the cavity created by the aircraft impact. Fourteen seconds later the smoke suddenly became very dark and heavy. Shortly afterward flames appeared. As evident in Figure 8-1, prior to this time little or no smoke was seen in this region, and the windows in the area appeared to be intact. This developing fire grew rapidly and by 8:52 a.m. fire was visible in windows 97-142 to 97-146, with flames extending from windows 97-144 and 97-145.

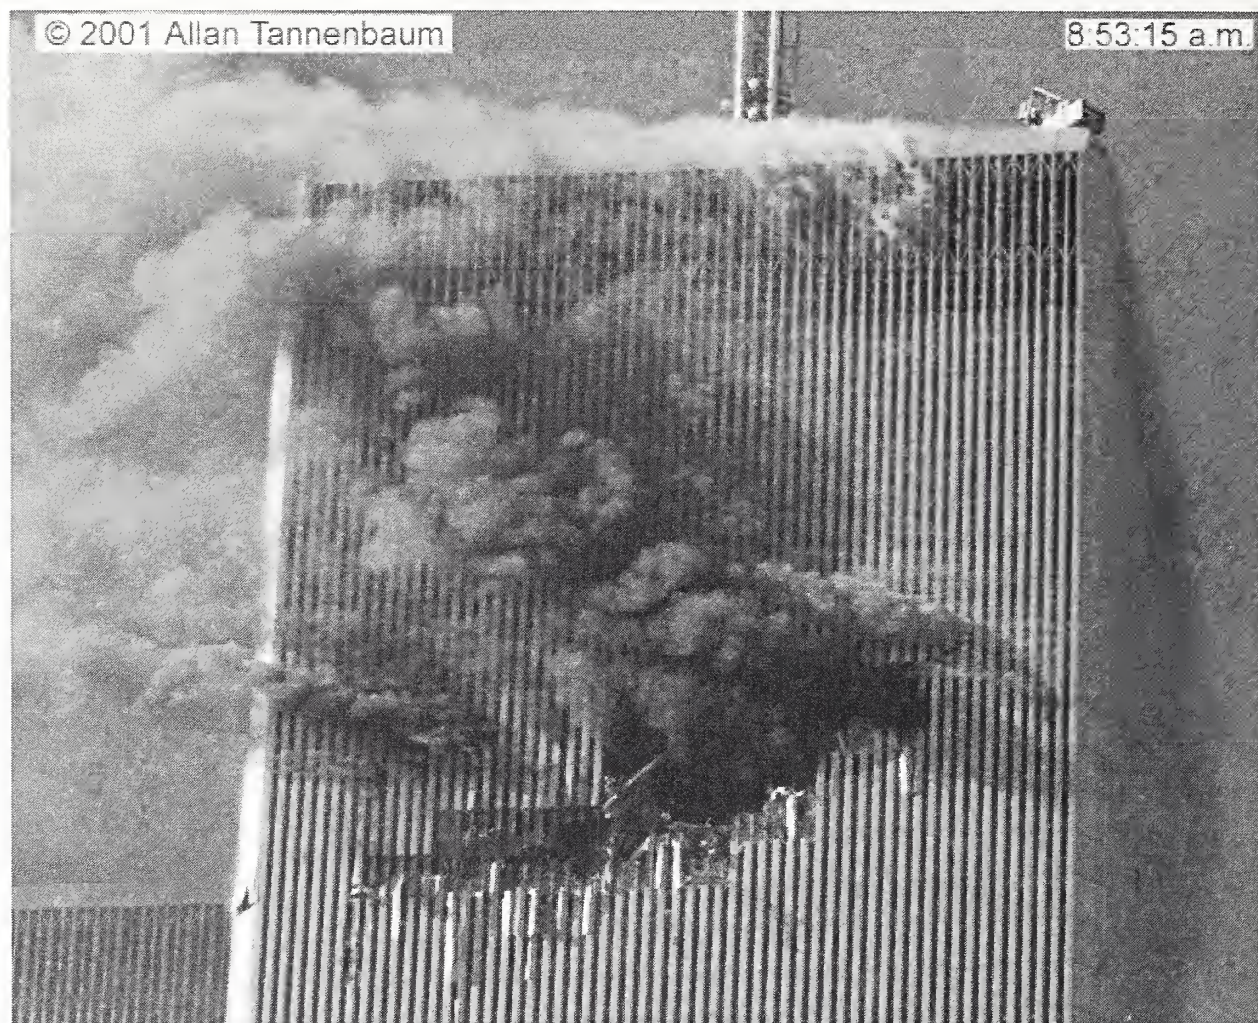
Figure 8-2, showing the north face, was shot at 8:53:15 a.m. An enlarged portion of the image is reproduced as Figure 8-3. The fire to the east of the aircraft impact area has continued to spread, now extending from windows 97-142 to 97-148. In three of the windows (97-142, 97-143, and 97-144) isolated fires are burning at the tops of the open window frames. Videos show that pieces of solid burning fuel from these areas eventually fell and formed the white streamers described in Section 5.2 as the material floated downward. Appendix L summarizes observations of streamers on the four faces of WTC 1. The first streamer from the left of the impact cavity was observed at 8:54:52 a.m., falling from the top of window 97-145, and many additional streamers were observed during the next few minutes.

In Figure 8-2 and Figure 8-3 light smoke is coming from near window 96-150. This smoke is an early indication of a developing fire that will appear shortly and grow rapidly in this area.

Smoke is also flowing from the mechanical equipment rooms at the 108th and 109th floors in Figure 8-2. Smoke and/or dust were observed coming from these floors immediately following the aircraft impact, suggesting that ductwork within the core area had been compromised. Smoke was observed continuously coming from these floors after the impact. As described in Section 4.2.5, the smoke was actually flowing from louvers mounted in an interior wall located nearly 5 feet behind the exterior facade that is visible. The smoke appears to be coming from three distinct locations centered near windows 113, 122, and 132. Figure A-1 in Appendix A shows the locations of the various louvers on these floors and identifies which parts of the ventilation system were serviced by these louvers. On the north face of WTC 1 the louvers were part of the fresh air intake system that serviced the upper portion of the building extending from the 92nd floor to the top. The three locations are close to the three intakes that provided air to the core, interior, and peripheral areas of the lower floors in the northwest quadrant of the building. The ductwork for these ventilation systems extended downward through a shaft located on the northwest corner of the core. Smoke was clearly entering these three sets of ducts at some point. It should be noted that in order for the smoke to backflow through the intakes as observed, it had to pass through an extensive series of fans, preheating and cooling coils, and air filters.

Figure 8-2. A photograph of the north face of WTC 1 recorded at 8:53:15 a.m. is shown. The original has been cropped.

At the time that the photograph in Figure 8-2 was taken, there was no indication that any windows on the north face above the 99th floor were missing. This situation changed abruptly 43 s later, i.e., at 8:53:58 a.m., when a light smoke plume appeared from the 104th floor at window 104-116. At the same time an object was seen falling from this location. This observation was the first indication on the north face that people trapped on floors above the aircraft impact area were breaking windows to provide access to outside air. Nine seconds later another object was observed falling from window 104-115, and shortly

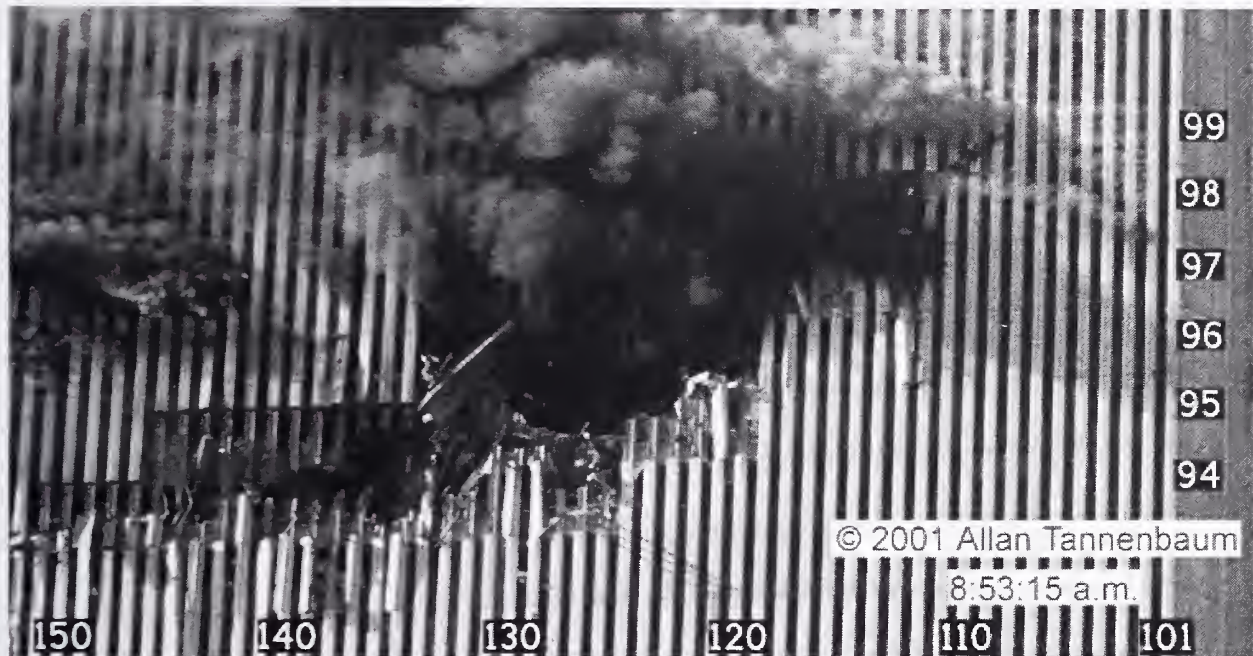
Figure 8-3. An enlargement of a portion of the photograph reproduced in Figure 8-2 showing the north face of WTC 1 at 8:53:15 a.m. is shown. Labels showing floor and column numbers have been added.
